# Project: RIVERBEND OF NAPLES SANITARY 11.27.2023

Pacp Quick Overall Rating: 352A

Pipe Segment Reference: MH-2 - C/O-1

Material: Vitrified Clay Pipe

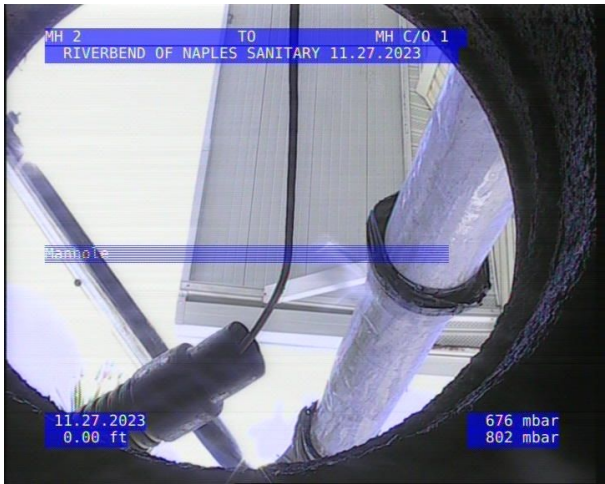
Distance	Fault Observation	Time	Picture
0.0	Manhole Severity: None Remarks: 2	48

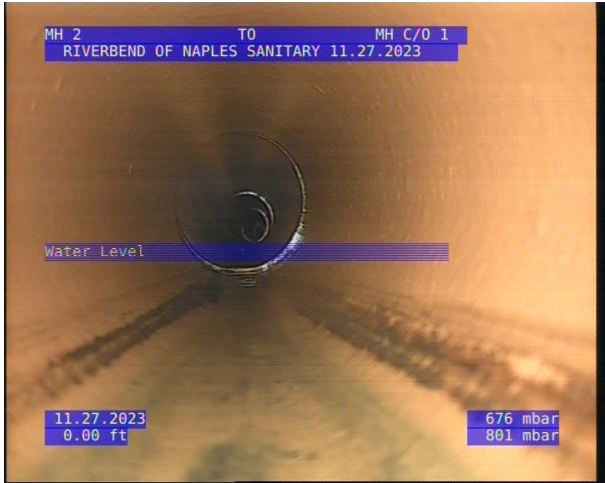
0.0	Water Level Severity: None Percent: 5	01:05

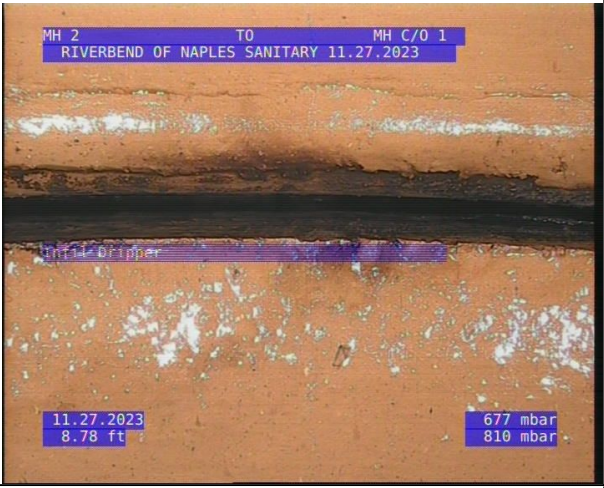
Distance	Fault Observation	Time	Picture
8.8	<p>Infil Dripper</p> <p>Position: 11</p> <p>Severity: None</p> <p>Joint</p> <p>Maint Weight: 3</p>	03:23

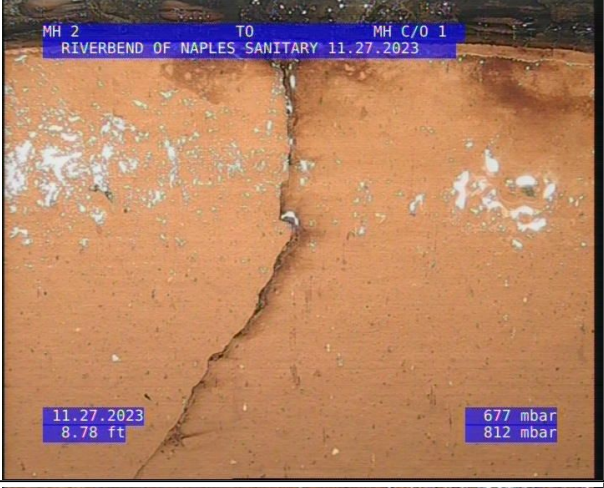
8.8	<p>Crack Longitudinal</p> <p>Position: 2</p> <p>Severity: None</p> <p>Struct Weight: 2</p>	04:07

(8.8) CL - Crack Longitudinal - Position: 2

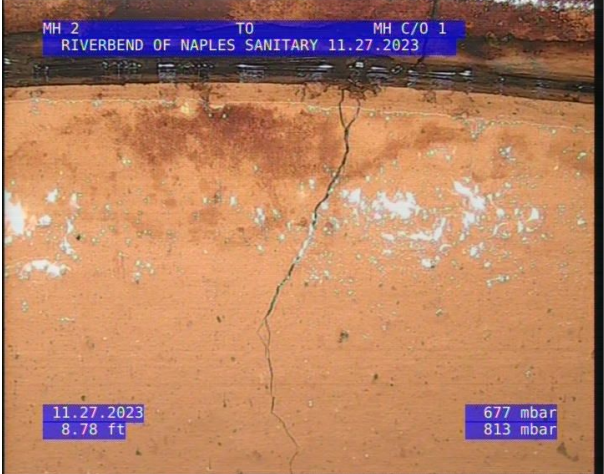
8.8	<p>Crack Longitudinal</p> <p>Position: 4</p> <p>Severity: None</p> <p>Struct Weight: 2</p>	04:35

(8.8) CL - Crack Longitudinal - Position: 4

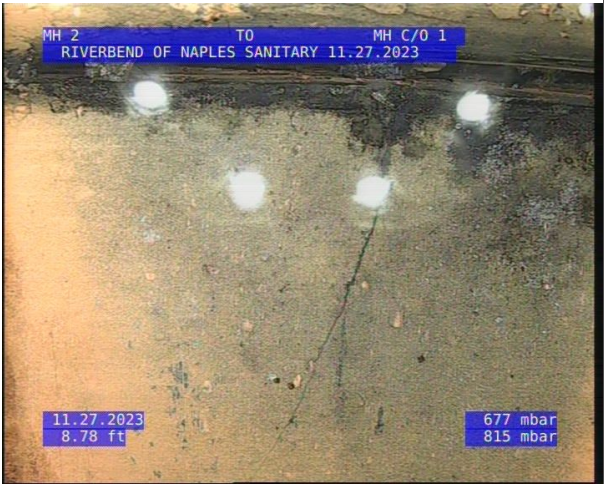
Distance	Fault Observation	Time	Picture
8.8	Crack Longitudinal Position: 6 Severity: None Struct Weight: 2	05:11

(8.8) CL - Crack Longitudinal - Position: 6

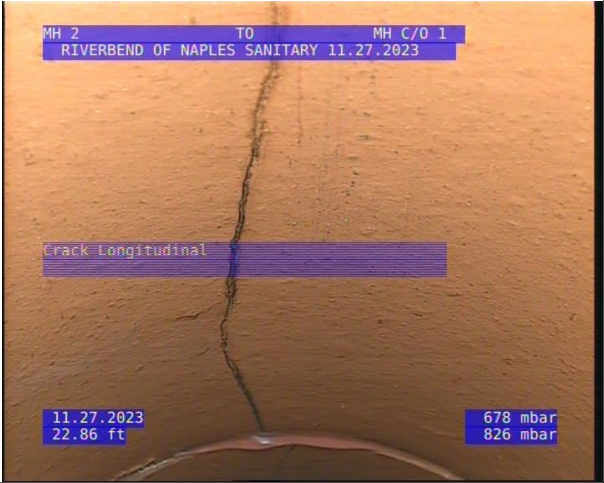
22.9	Crack Longitudinal Position: 11 Severity: None Struct Weight: 2	09:13

(22.9) CL - Crack Longitudinal - Position: 11

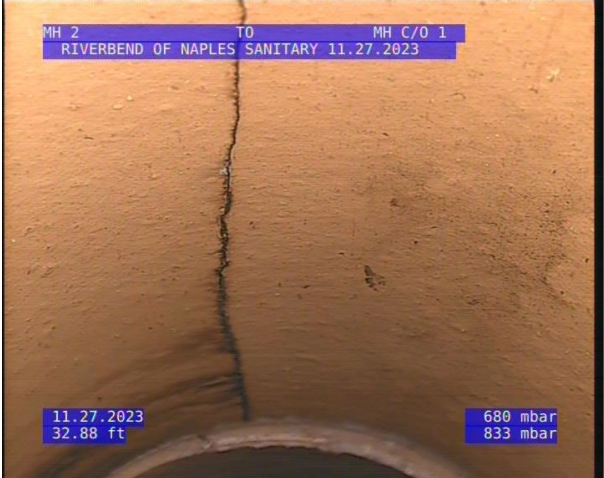
32.9	Crack Longitudinal Position: 10 Severity: None Struct Weight: 2	11:51

(32.9) CL - Crack Longitudinal - Position: 10

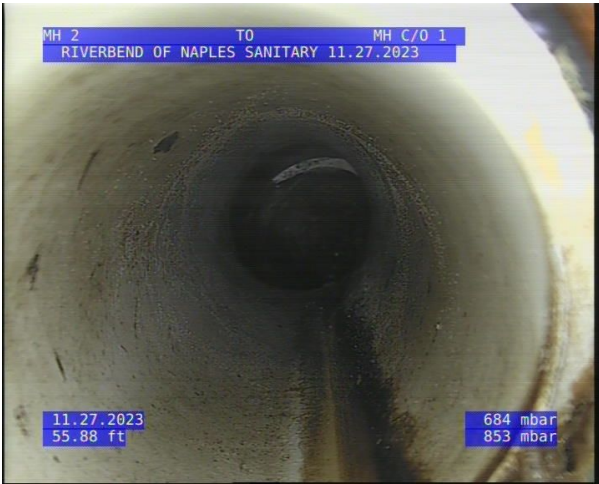
Distance	Fault Observation	Time	Picture
55.9	<p>Tap Factory Position: 12 Severity: None Size: 6</p>	19:23

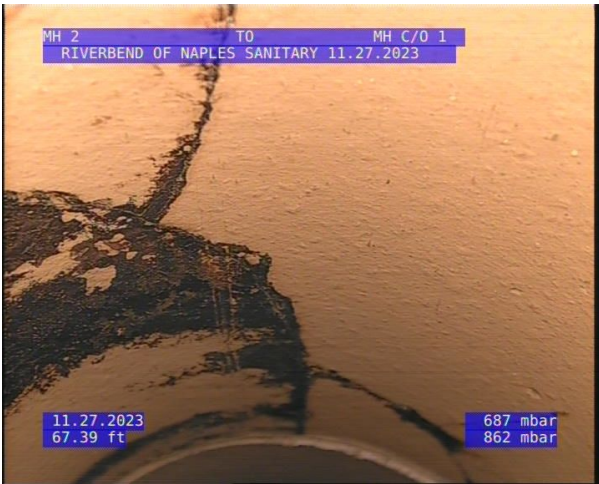
67.4	<p>Crack Spiral Position: 6 To 12 Severity: None Struct Weight: 2</p>	22:41

(67.4) CS - Crack Spiral - Position: 6 To 12

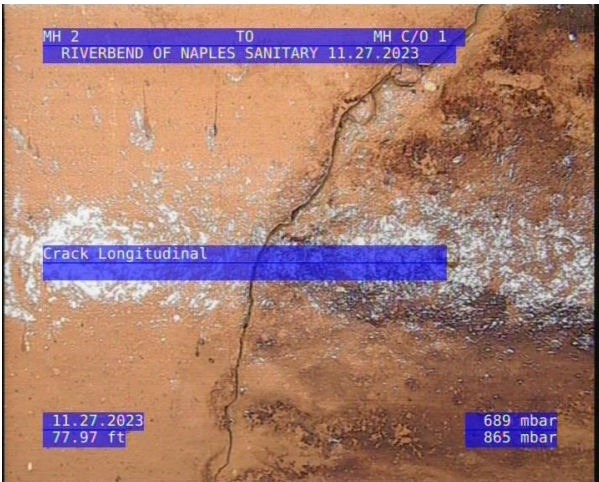
78.0	<p>Crack Longitudinal Position: 4 Severity: None Struct Weight: 2</p>	25:06

(78.0) CL - Crack Longitudinal - Position: 4

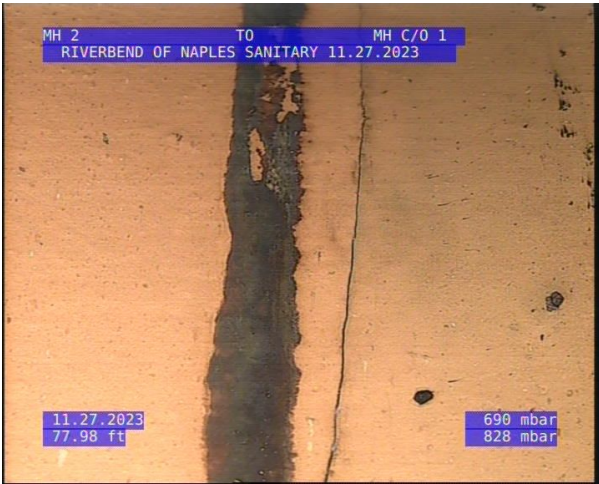
Distance	Fault Observation	Time	Picture
78.0	Crack Longitudinal Position: 7 Severity: None Struct Weight: 2	25:44

(78.0) CL - Crack Longitudinal - Position: 7

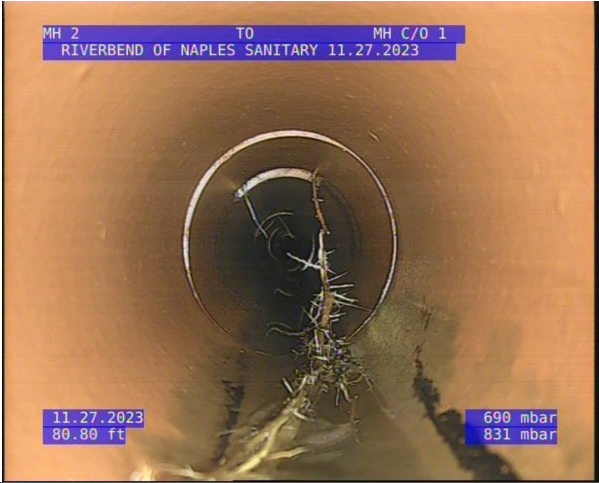
<p>MH 2 TO MH C/O 1 RIVERBEND OF NAPLES SANITARY 11.27.2023</p> <p>11.27.2023 77.98 ft 690 mbar 828 mbar</p>
80.8	Roots Fine Connection Position: 12 To 6 Severity: None Cont Defect: S01 Maint Weight: 1	26:54

(80.8) RFC - Roots Fine Connection - Position: 12  
To 6 - Cont Def: S01

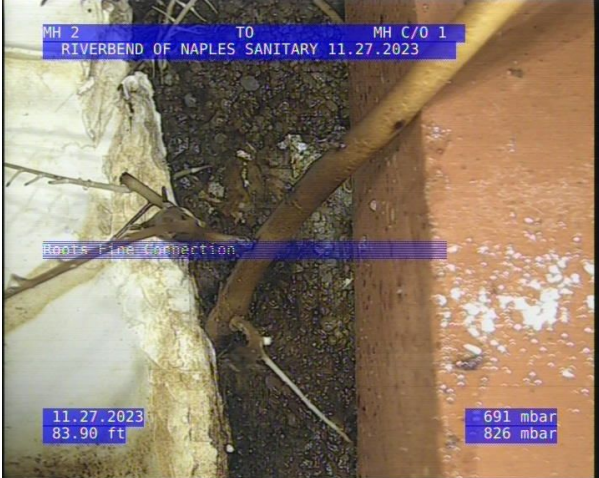
<p>MH 2 TO MH C/O 1 RIVERBEND OF NAPLES SANITARY 11.27.2023</p> <p>11.27.2023 80.80 ft 690 mbar 831 mbar</p>
83.9	Roots Fine Connection Position: 12 To 6 Severity: None Cont Defect: F01 Maint Weight: 1	28:20

(83.9) RFC - Roots Fine Connection - Position: 12  
To 6 - Cont Def: F01

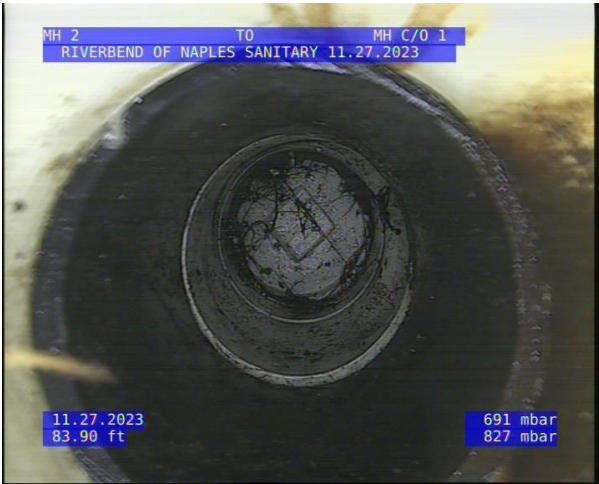
Distance	Fault Observation	Time	Picture
83.9	<p>Tap Factory Position: 12 Severity: None Size: 6</p>	28:42

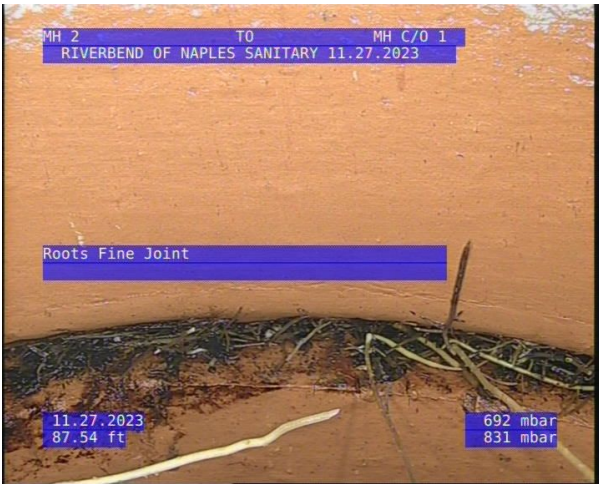
87.5	<p>Roots Fine Joint Position: 9 To 1 Severity: None Joint Maint Weight: 1</p>	30:34

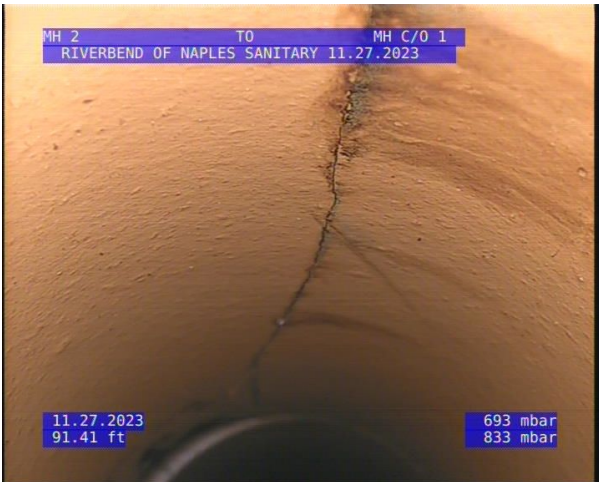
91.4	<p>Crack Longitudinal Position: 1 Severity: None Struct Weight: 2</p>	31:26

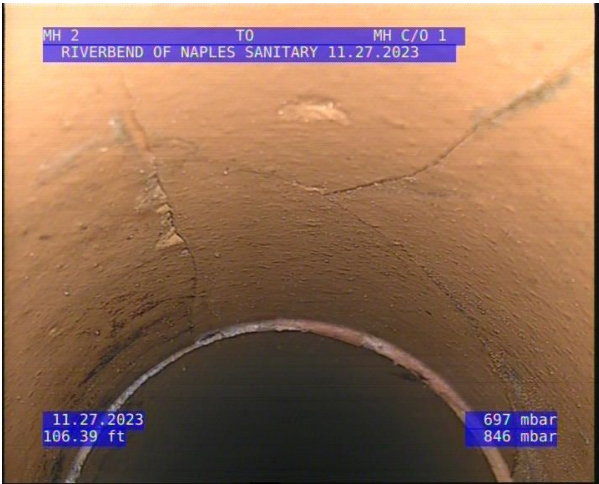
Distance	Fault Observation	Time	Picture
106.4	<b>Crack Multiple</b> <b>Position: 11 To 3</b> <b>Severity: None</b> <b>Struct Weight: 3</b>	37:04

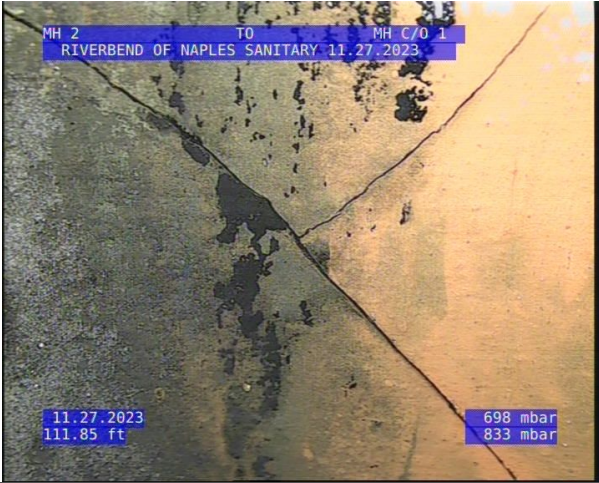
111.8	<b>Crack Multiple</b> <b>Position: 5 To 9</b> <b>Severity: None</b> <b>Struct Weight: 3</b>	40:19

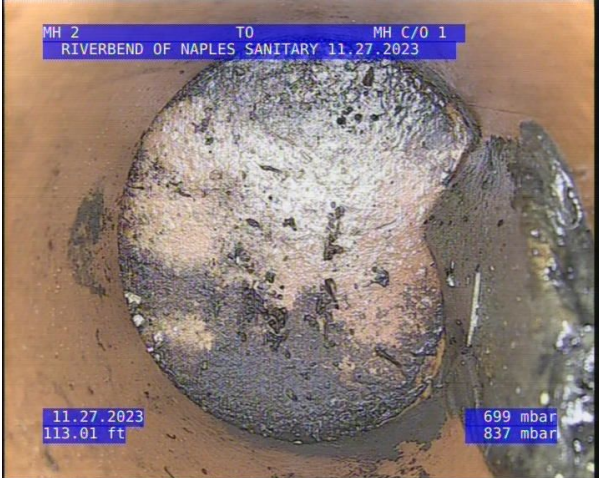
113.0	<b>Tap Factory</b> <b>Position: 2</b> <b>Severity: None</b> <b>Size: 6</b> <b>Remarks: CAP</b>	41:24

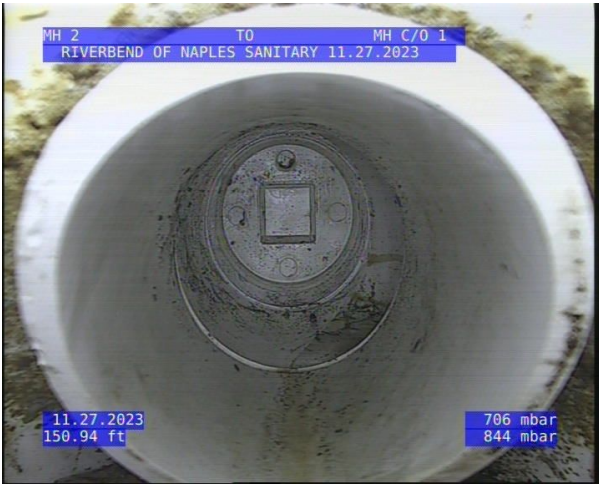
Distance	Fault Observation	Time	Picture
150.9	<p>Tap Factory Position: 12 Severity: None Size: 6</p>	48:10

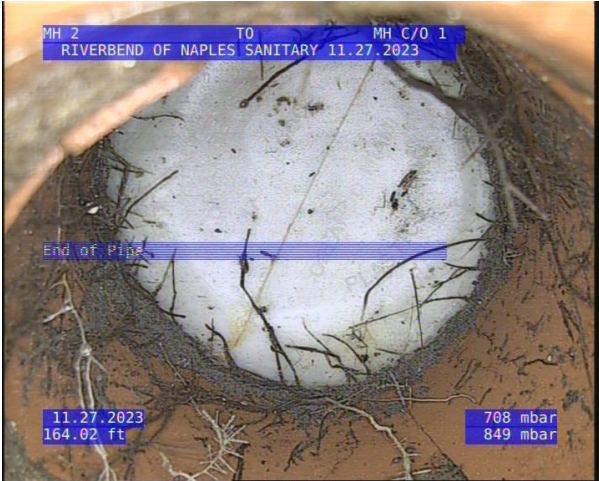
164.0	<p>End of Pipe Severity: None Remarks: C/O 1</p>	51:46
