# Project: RIVERBEND OF NAPLES SANITARY 11.27.2023

Pacp Quick Overall Rating: 352A

Pipe Segment Reference: MH-2 - C/O-1

Material: Vitrified Clay Pipe

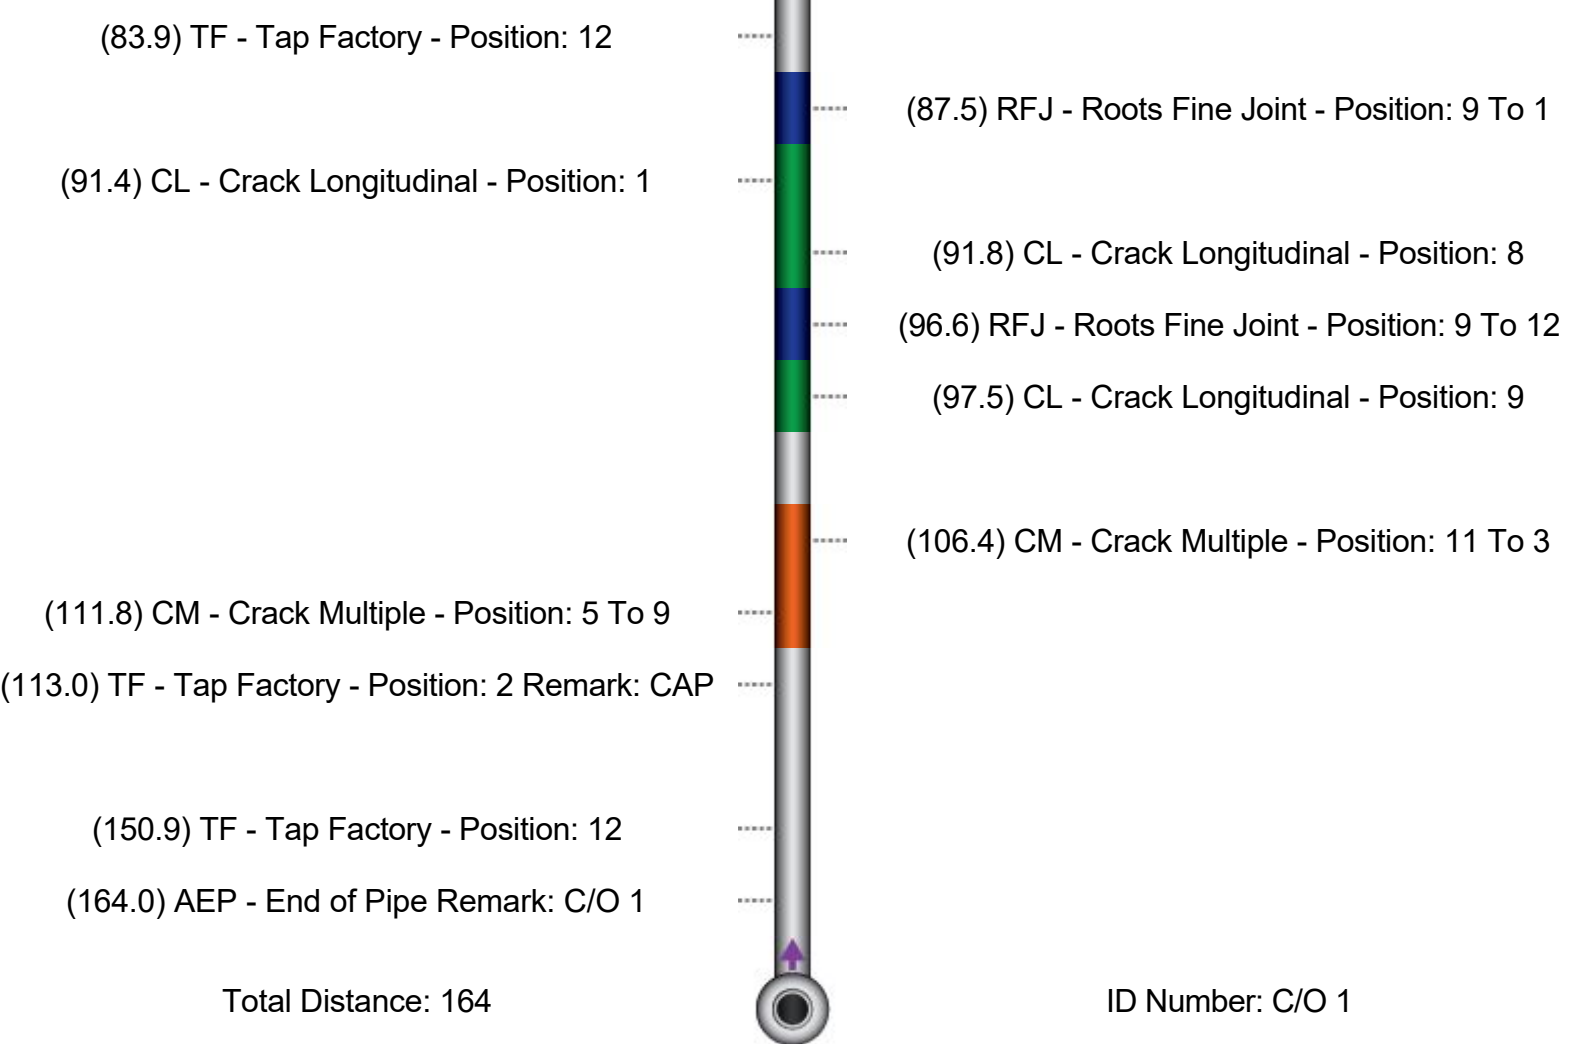
(8.8) CL - Crack Longitudinal - Position: 6

(22.9) CL - Crack Longitudinal - Position: 11

(32.9) CL - Crack Longitudinal - Position: 10

(54.5) CL - Crack Longitudinal - Position: 11

(67.4) CS - Crack Spiral - Position: 6 To 12

(78.0) CL - Crack Longitudinal - Position: 7
